Corrosion behaviour of steels in flowing lead-bismuth

Nuclear Research Institute Řež
Czech Republic

*The Vth International Workshop on Materials for HLM-cooled Reactors and Related Technologies,
April 20-22, 2009, Mol*

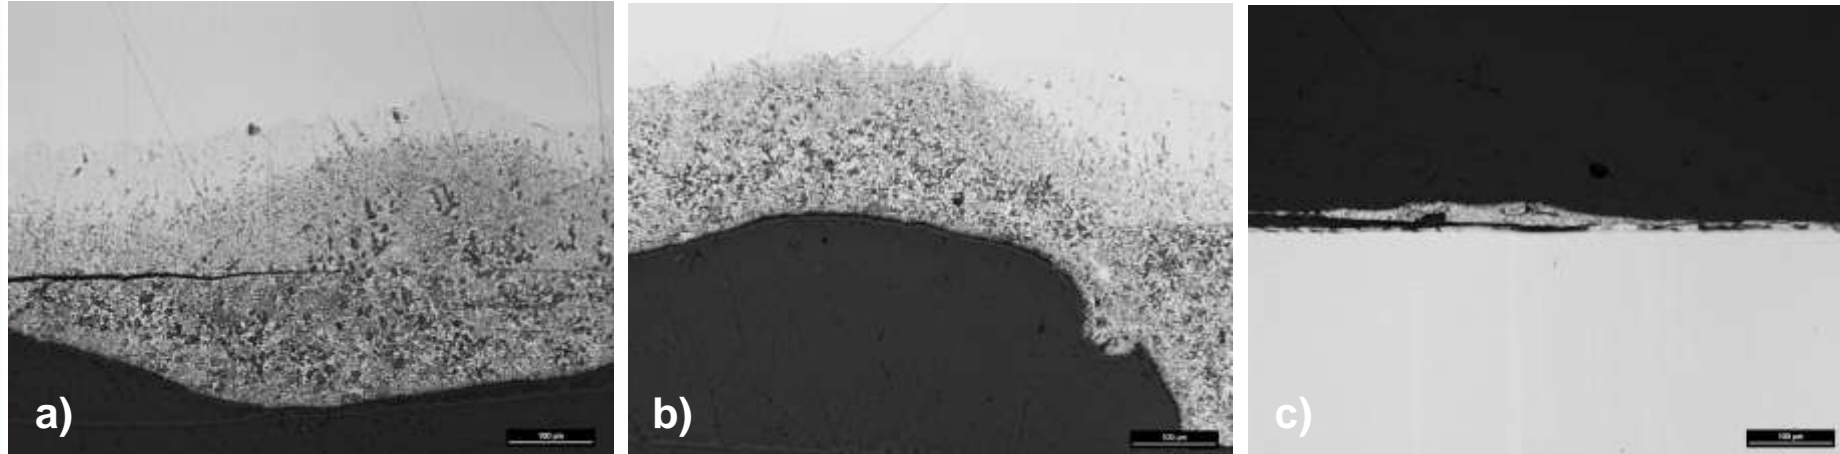
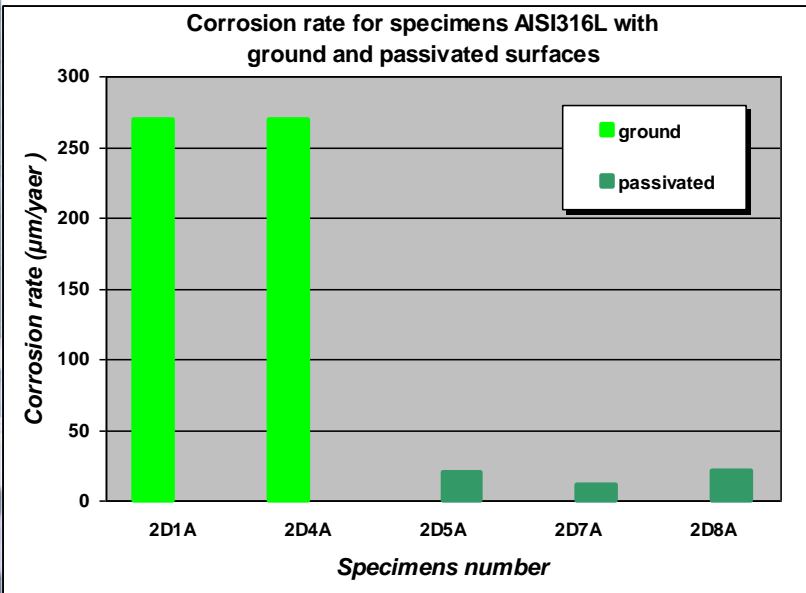
Results AISI 316L

GROUND SURFACE – a) and b)

Penetration of LBE in bulk of material.
Two layers on the surface.

Abundant metal loss.

Ni and Cr depletion

PASSIVATED SURFACE – c)

Slightly damaged on the specimen surface

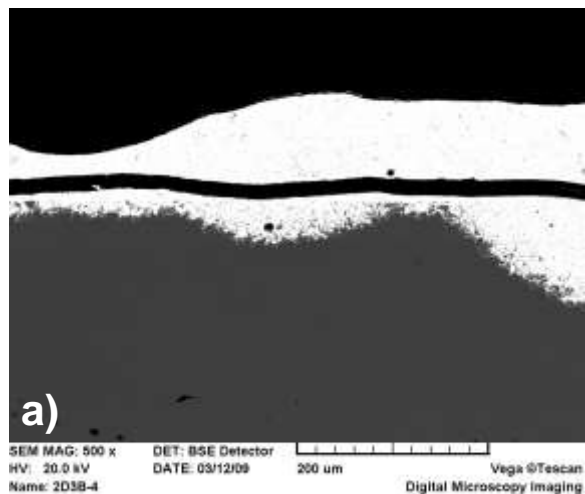
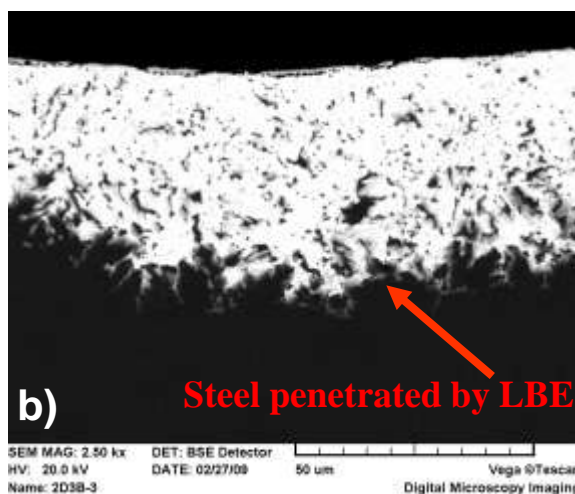
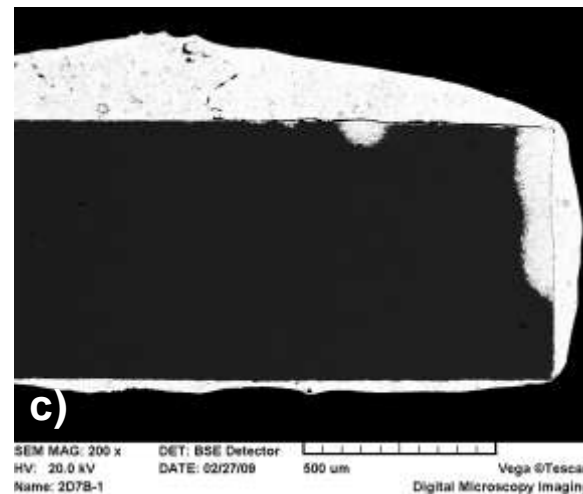
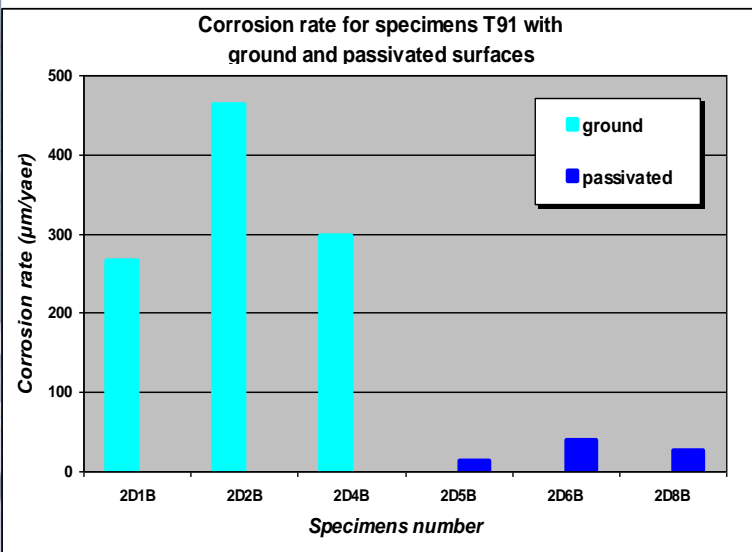
GROUND SURFACE – a) and b)

LBE penetration along grain boundaries and localised pits were observed.

PASSIVATED SURFACE – c)

Slightly damaged on the specimen surface

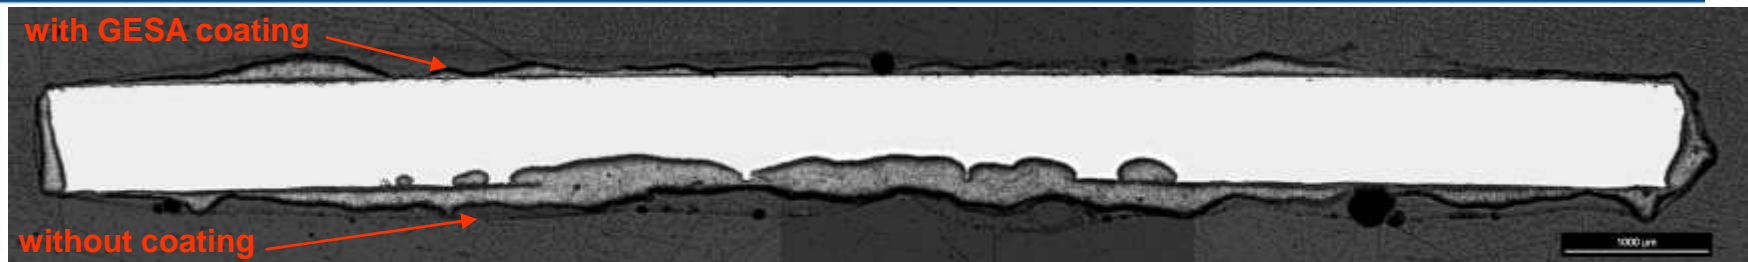
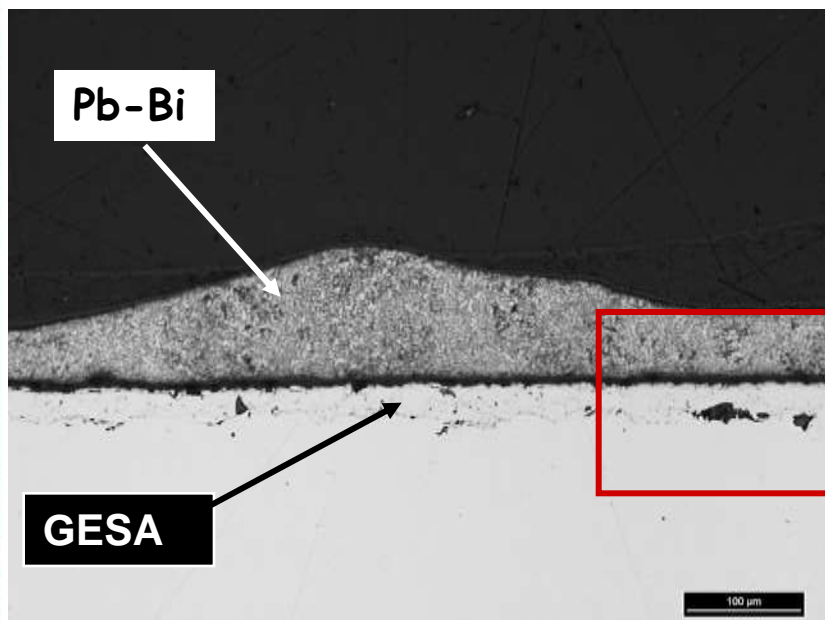
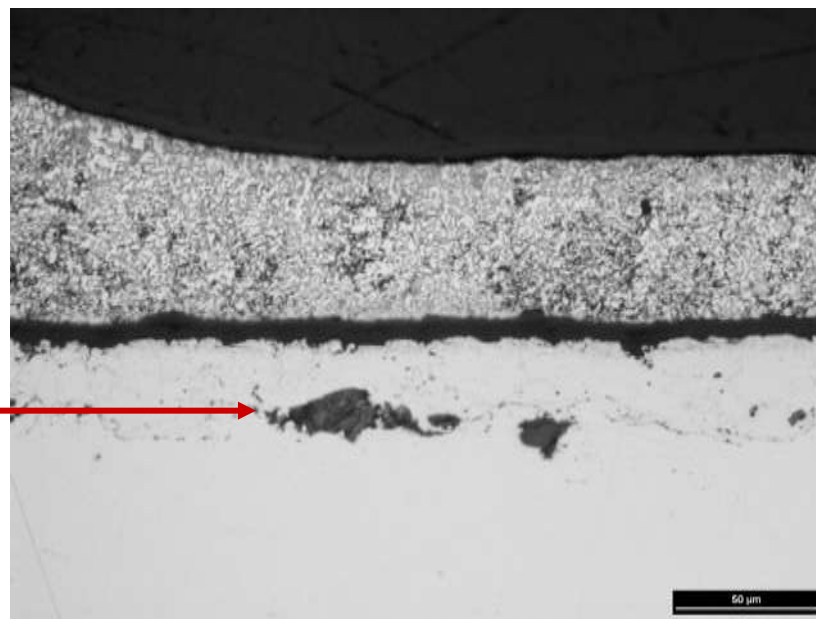
Results T91 + GESA

Any type of damage of T91+GESA didn't observed on the surface with coating **BUT**

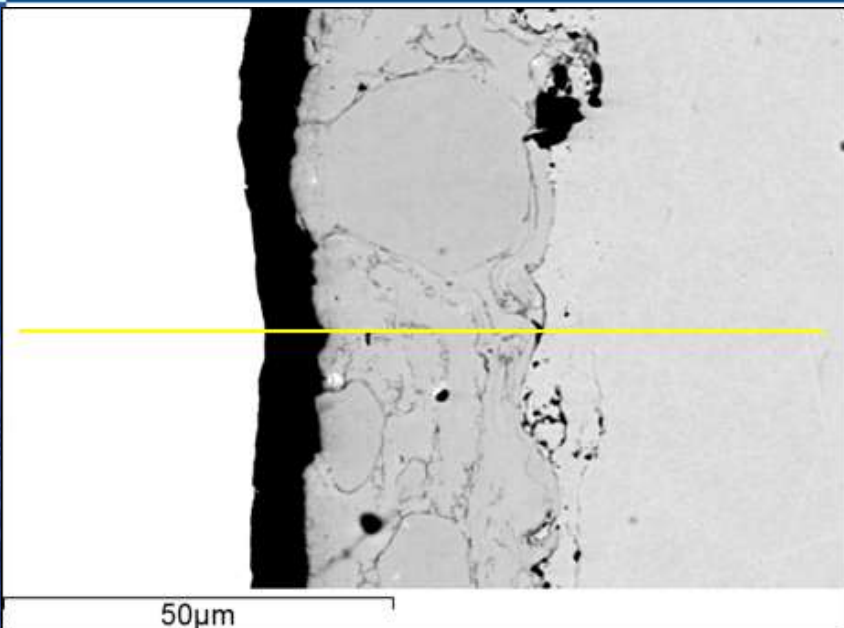
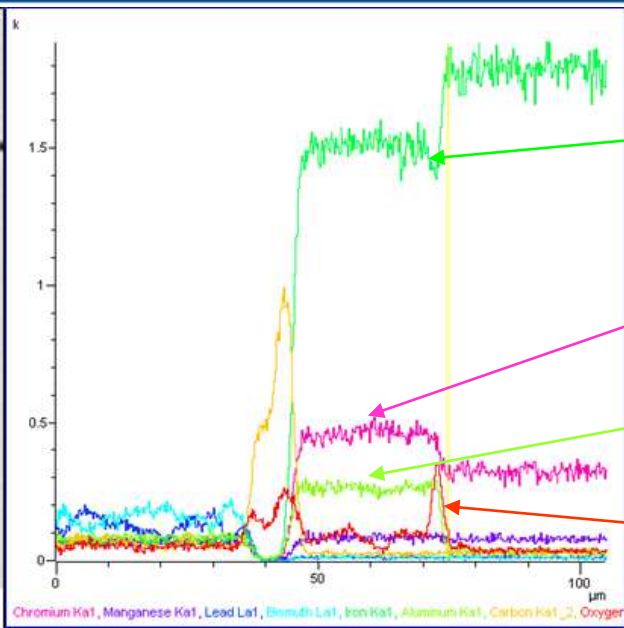
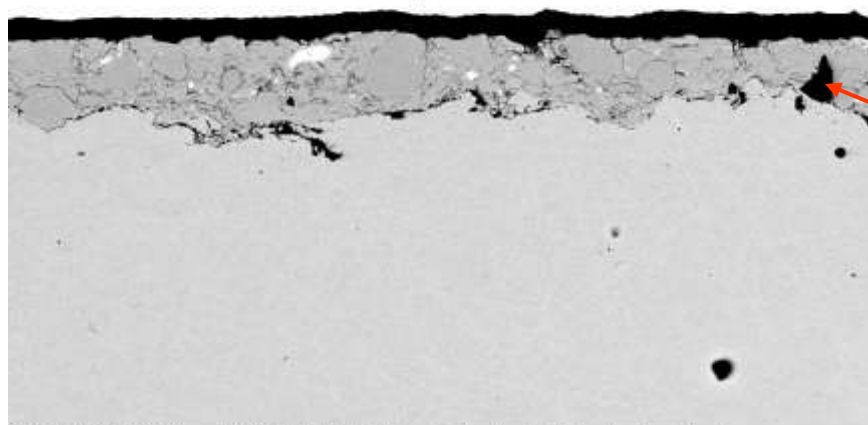
Results T91 + GESA

Fe
Cr
Al
O

Aluminum 50 wt%
Oxygen 49 wt%

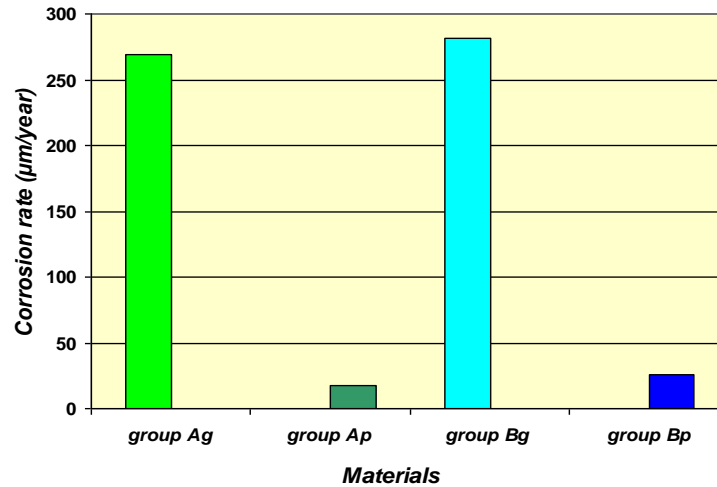
Summary results

The amount of damage of ground surface was higher (about 10 times) than the damage measured of passivated surface for both material
